Sterling Supplies - Black PVD Stainless Tactiles - Wet Sliptest KO130522-1

Slip Resistance Classification of New Pedestrian Surfaces - AS4586:2013 Appendix A

| Test Report Number: | KO130522-1 |

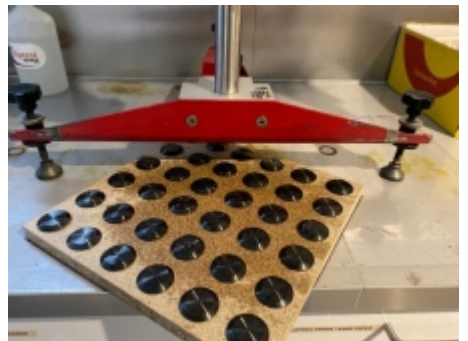
| Test Site / Surface Tested : | Black PVD Stainless Tactiles - Applied to 300x300cm MDF Board |

| Sample No. | Swing 1 | Swing 2 | Swing 3 | Swing 4 | Swing 5 | Mean BPN of last 3 swings : | SCV : | Surface Picture |
| Area 3 | 90 | 90 | 90 | 89 | 89 | 89 | N/A | |

Variation to Standard Mean BPN Slip Resistance Value (SRV) 88

CLASSIFICATION using Slider 96 (4S Slider) P5 = > 54
