Sterling Supplies - Carplex Ribbed Cushion Back Sample Nosing - Wet Sliptest AN180123-3

Slip Resistance Classification of New Pedestrian Surfaces - AS4586:2013 Appendix A

Date Tested:	18 Jan 2023
Test Report Number:	AN180123-3
Client Name & Billing Address:	Sterling Supplies - 28-34 Paraweena Drive Truganina Victoria 3029
Project Name or Test Location:	"Carplex Ribbed Cushion Back" Sample Nosing
Surface Tested : (Samples and Test Information Supplied by Client)	"Carplex Ribbed Cushion Back"
Wet Pendulum Test carried out using :	Slider 96 (4S) Rubber slider
Testing Officer / Approved Signatory:	Alyssa Neill
Pendulum in use - Calibration Date :	#2047 - Munro-Stanley Portable Skid Tester (C : 25.08.2022)
Signature of Approved Signatory :

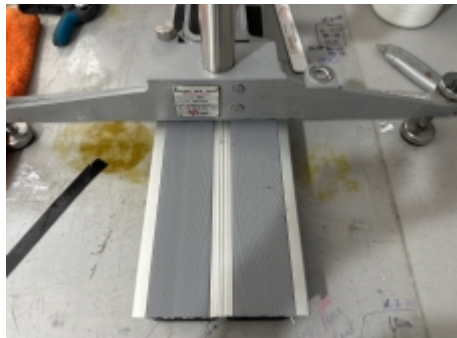
Sample No.	Swing 1	Swing 2	Swing 3	Swing 4	Swing 5	Mean BPN of last 3 swings :	SCV :	Surface Picture
1A	55	55	55	55	55	55	N/A	
1B	55	55	55	55	55	55	N/A	
1C	55	54	54	52	52	53	N/A	
1D	52	52	51	50	50	50	N/A	
1E	55	55	55	55	55	55	N/A

Reported SRV For Test Area : 54

CLASSIFICATION using Slider 96 (4S Slider) P4 = 45 - 54
