**Sterling Supplies - 300x300mm Polymeric Hazard Tile - Wet Sliptest KO151220-7**

**15 Dec 2020**

### Slip Resistance Classification of New Pedestrian Surfaces - AS4586:2013 Appendix A

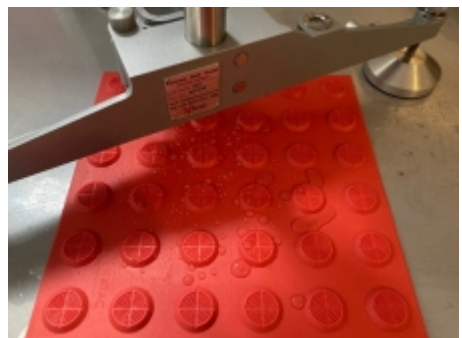
Sample No.	Swing 1	Swing 2	Swing 3	Swing 4	Swing 5	Mean BPN of last 3 swings :	SCV :	Surface Picture
Area 1A	44	42	42	42	42	42	N/A	
Area 1B	42	42	42	42	41	42	N/A	
Area 1C	43	43	42	42	42	42	N/A

Variation to Standard Mean BPN Slip Resistance Value (SRV) 42

Corrected Mean BPN (SRV) Slider 55 ONLY 43

CLASSIFICATION using Slider 55 (TRL Slider) P4 = 40 - 44
