Luminance Contrast Report

Product: Appular Ribbed Stair Nosing
Product Code: SN-APR - Various
Address: 8a Lara Way, Campbellfield VIC 3061
Testing Date: 29/09/2022

Product Name: Appular Ribbed Stair Nosing

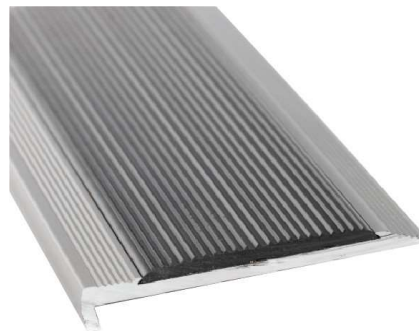
Product Description:
 Aluminium Stair Nosing with Ribbed Vinyl Profile
